**SONIC BOOMS RESULTING FROM EXTREMELY
LOW-ALTITUDE SUPERSONIC FLIGHT: MEASUREMENTS
AND OBSERVATIONS ON HOUSES, LIVESTOCK AND PEOPLE**

OCTOBER 1968

AEROSPACE MEDICAL RESEARCH LABORATORIES
AEROSPACE MEDICAL DIVISION
AIR FORCE SYSTEMS COMMAND
WRIGHT-PATTERSON AIR FORCE BASE, OHIO

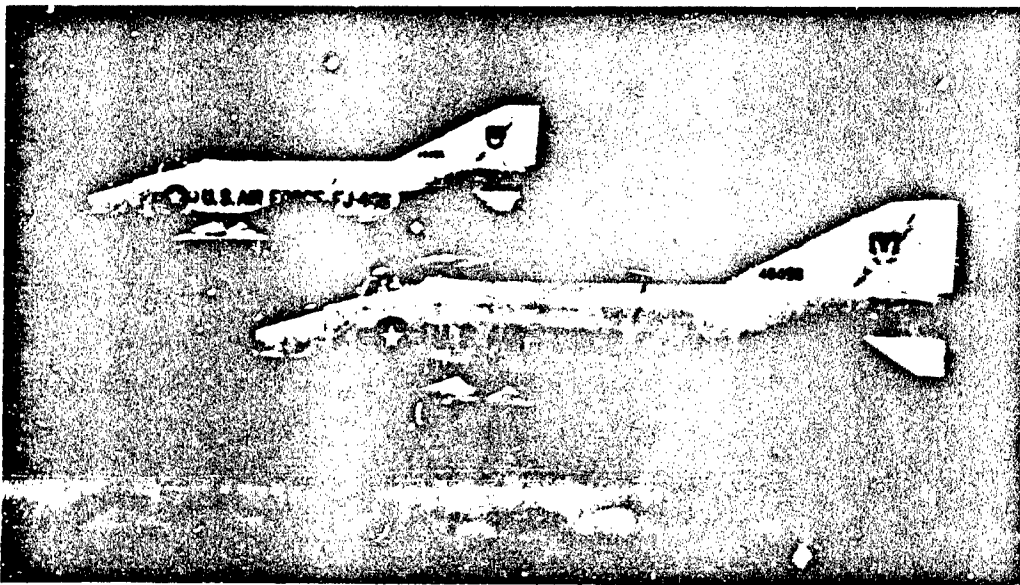
Fig. 1. F-4C Fighter Aircraft Used to Generate Sonic Booms

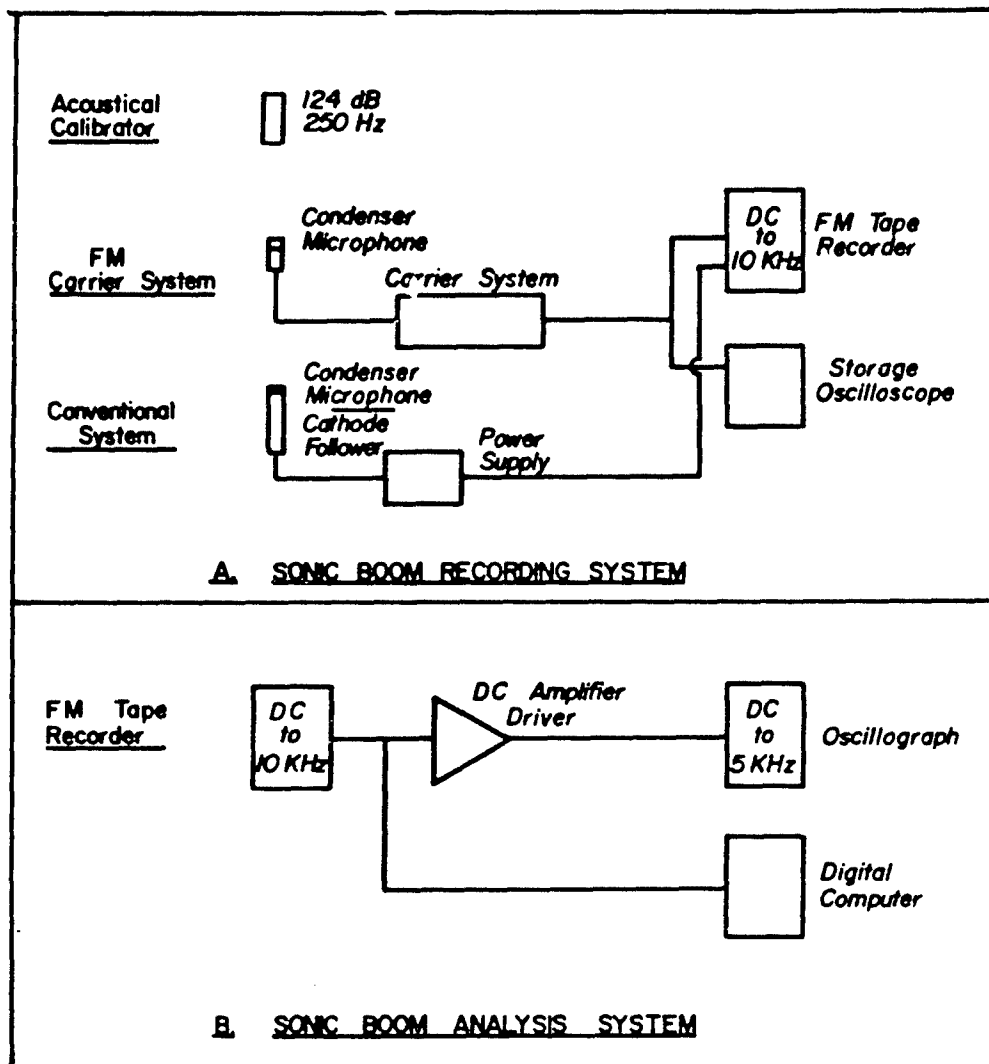
Fig. 3. Block Diagram of Instrumentation System

Ground overpressure instrumentation consisted of conventional commercially available equipment normally used for the measurement of high intensity noise. Two identical and independent recording stations were employed as shown in figure 3-A, each consisting of a multichannel tape recording system and three condenser microphones with associated microphone complements. Simultaneous recordings of the individual sonic booms were obtained at various locations at the main recording station: one microphone was located at ground level and the other two were shock mounted side-by-side at a height of 6 feet above the ground (fig. 4).

The ground microphone and one microphone mounted at the 6-foot level were connected to FM modulated record amplifiers (frequency range 0 to 10,000 Hz) and the other microphone was connected to an AM modulated record amplifier (frequency range 100 to 25,000 Hz). The latter channel recorded the higher frequency energy contained in the overpressure signature

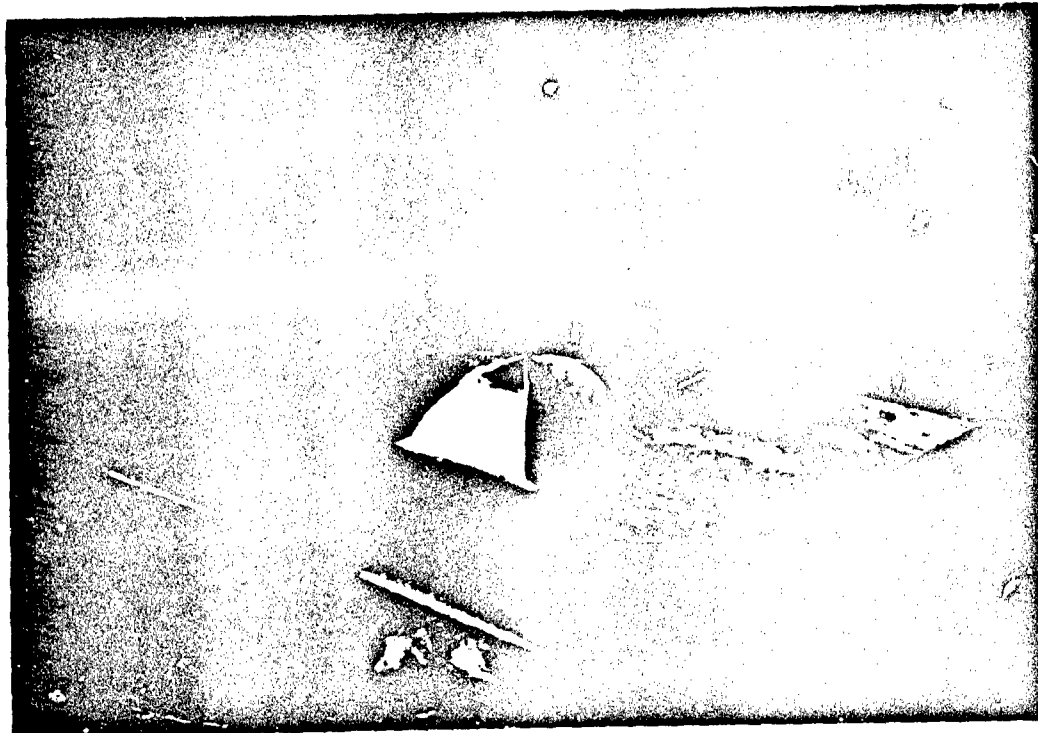
**Fig. 3. Microphone Mounting Board with Wind Screen
for Ground Level Measurements**

The microphone positioned at ground level was shock mounted in the surface of a 4 by 4 feet, 3/4-inch-thick plywood board. This board was firmly attached to the ground. A silk screen was placed over the microphone to protect it from dirt and sand and to reduce possible effects of the wind (fig. 5). This mounting arrangement was adopted from the method utilized by the NASA, Langley Research Center in their sonic boom measurement programs.

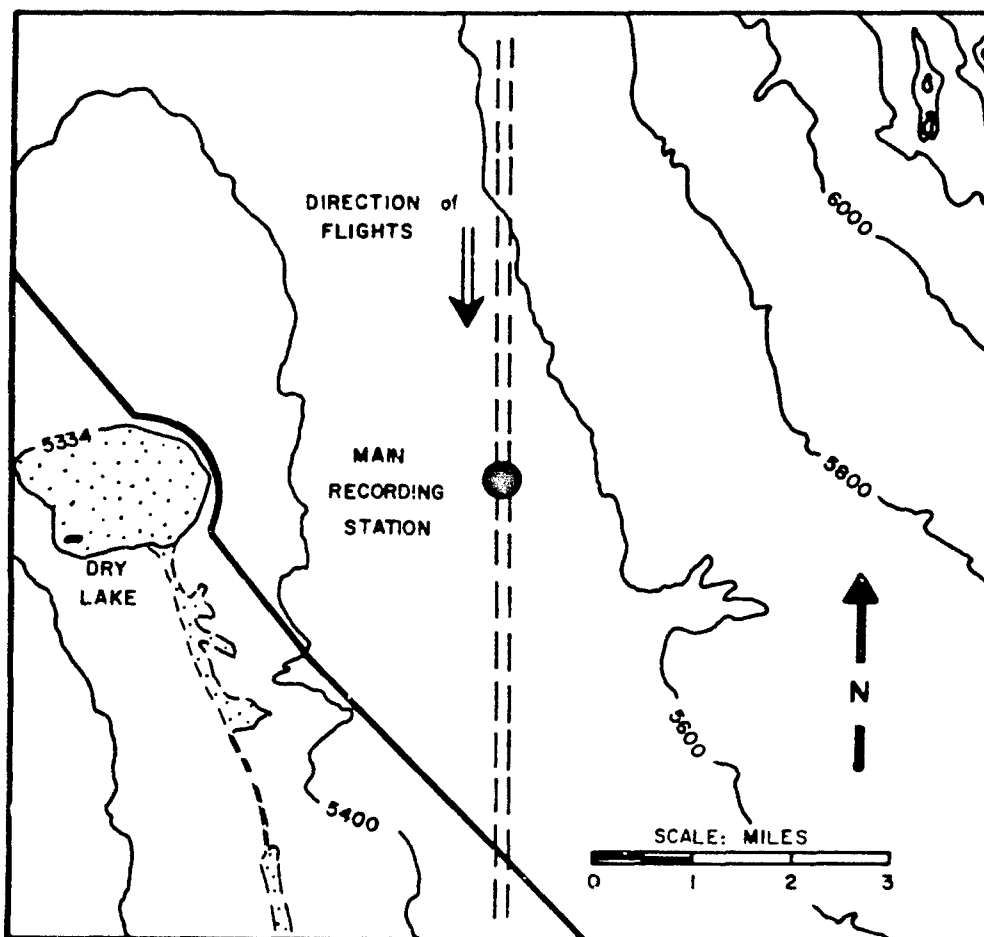
Fig. 6. Contour Map Showing Terrain at Main Recording Station on Track B

Ground overpressure values for the F-4C fighter aircraft are summarized in table II as a function of altitude and Mach number. Ground clearance ranged from about 85 feet to 125 feet at Station 1 while Mach numbers ranged from 1.11 to 1.30. The highest positive peak overpressures were measured at Station 1 (Flights 1 thru 7) where aircraft passed at minimum altitudes. The terrain was reasonably flat at this location as can be seen in figures 6 and 7.

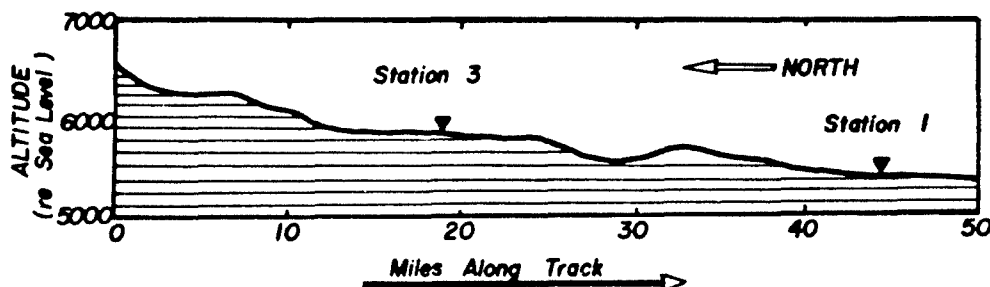
Fig. 7. Terrain Profile of Center Track (B) Flights Traveled from North to South

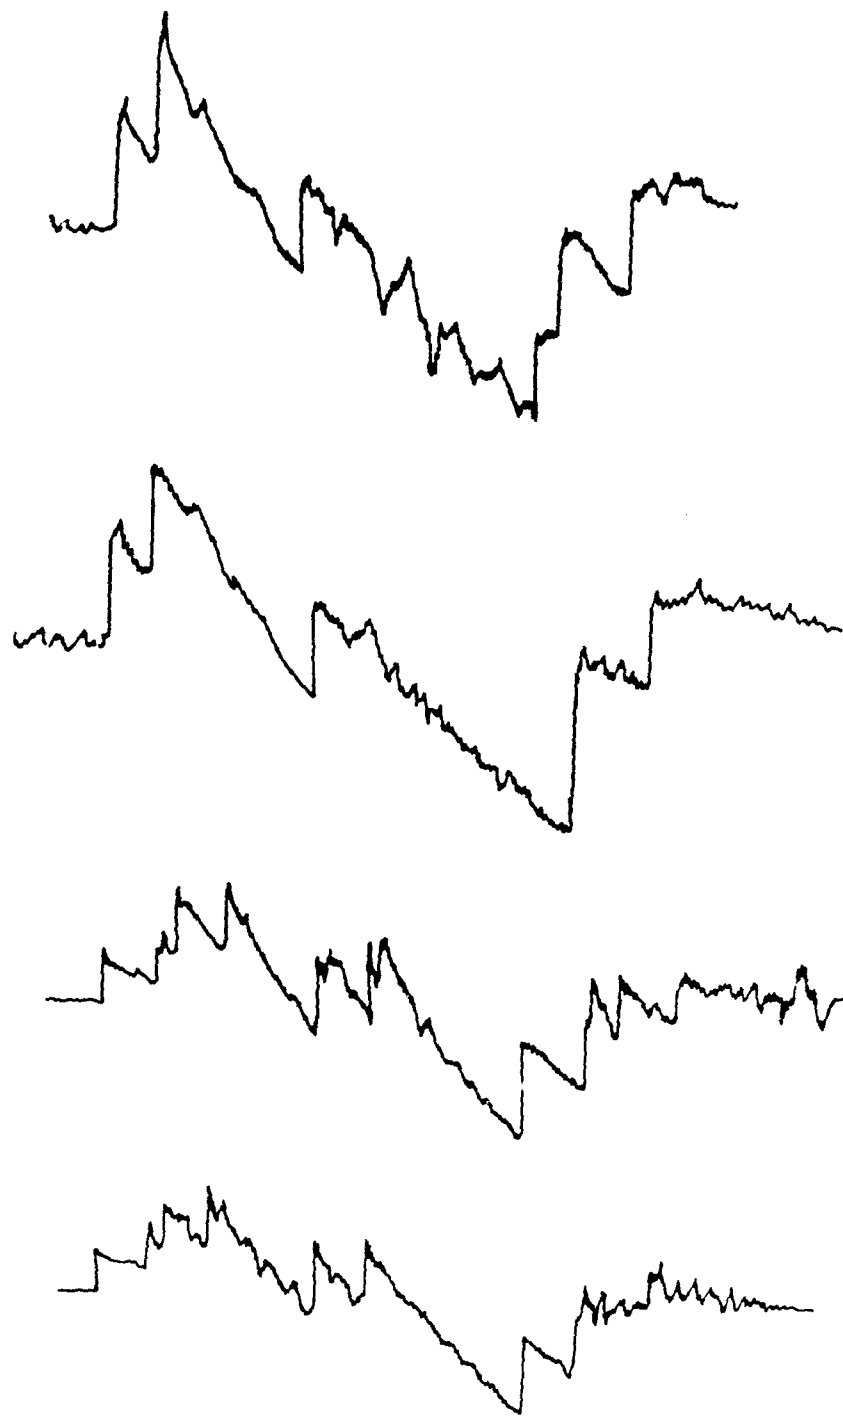
Fig. 8. Representative Pressure Time Histories Measured at 6 Feet for the R-4C at an Average Altitude of 100 Feet

Examination of the detailed tracking data shows that the aircraft were essentially "straight and level" over this station so that measured sonic booms are interpreted as not influenced by aircraft maneuver. Peak overpressure levels ranged from about 80 psf to 144 psf directly under the flight track and from 50 psf to 118 psf at various distances to the side of the ground track at Station 1. In general, higher overpressures corresponded to lower altitudes and higher Mach numbers as would be predicted from theoretical and experimental data. However, the extremely low ground clearance as well as the numerous irregularities in the configuration of this aircraft resulted in highly irregular near-field signatures and as a result interpretation of positive peak overpressure was not always a clear and easy determination. Some representative near-field pressure-time histories from the F-4C are presented in figure 8.

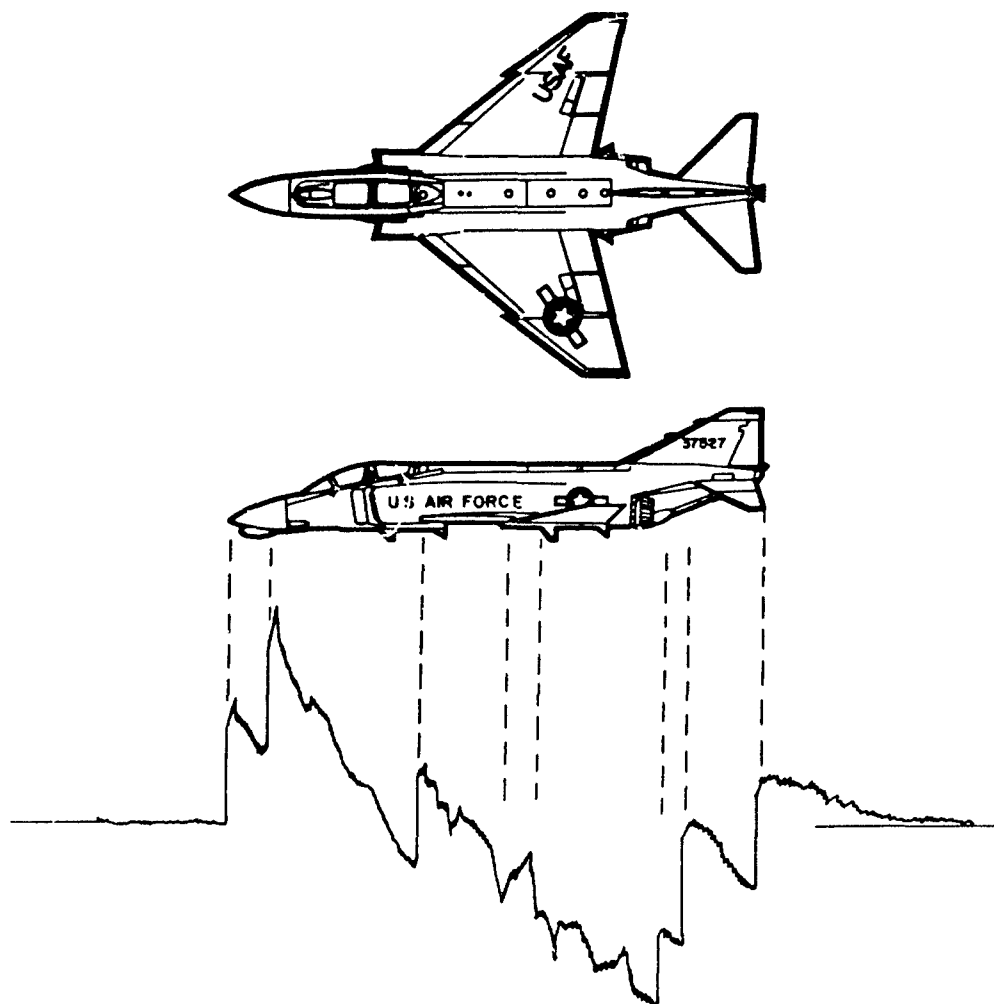
Fig. 9. Planform and Side Views of the F-4C with a Typical Pressure Time History

The pressure signature shown in figure 9 reflects the basic features of the N-wave, however the general configuration is quite ragged. In view of the near vicinity of the aircraft to the

measuring station the effects of atmosphere on propagation are considered to be quite small or even negligible. Signature irregularities are attributed primarily to the irregular surface configurations of the aircraft with the numerous individual leading edge shock waves being propagated to the ground. The relationship of some of these individual peaks in the signatures to

irregularities in the aircraft body surfaces are evident. The fact that the signature actually trails behind the aircraft with the shock waves bending to the rear is ignored for this pictorial presentation.

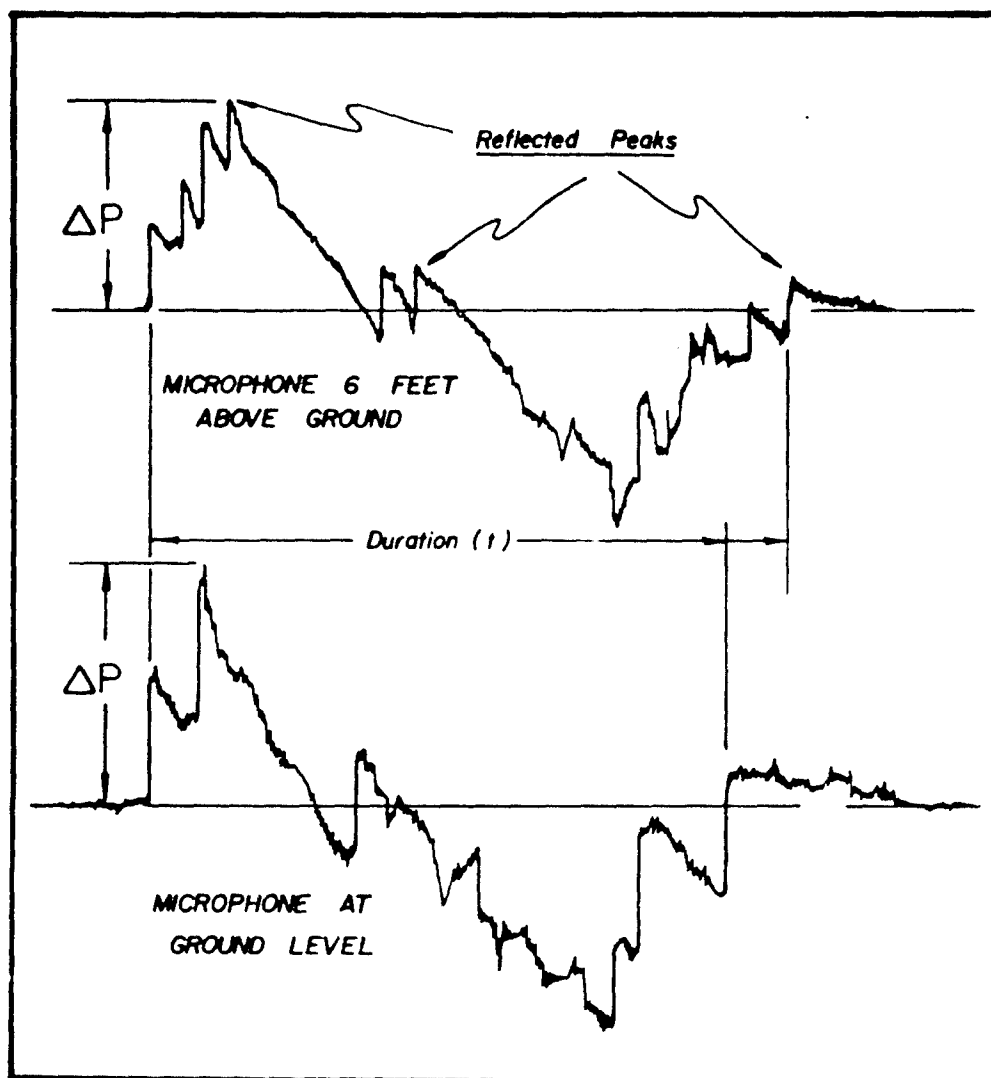
Fig. 10. Pressure Time History Measured at Ground Level and at 6 Feet

The sonic boom time history of signature A was recorded at ground level and signature B was recorded at a height of 6 feet above the ground (fig. 10). Signature B clearly displays both the incident shock wave as it was propagated from the aircraft to the ground and the reflected wave as bounced off the surface of the ground. Since the incident and reflected waves are identical at ground level no reflected element is present in signature A (ground level). Peak overpressures measured at ground level were equal to or greater than at the 6-foot level due to the ground reflection factor.

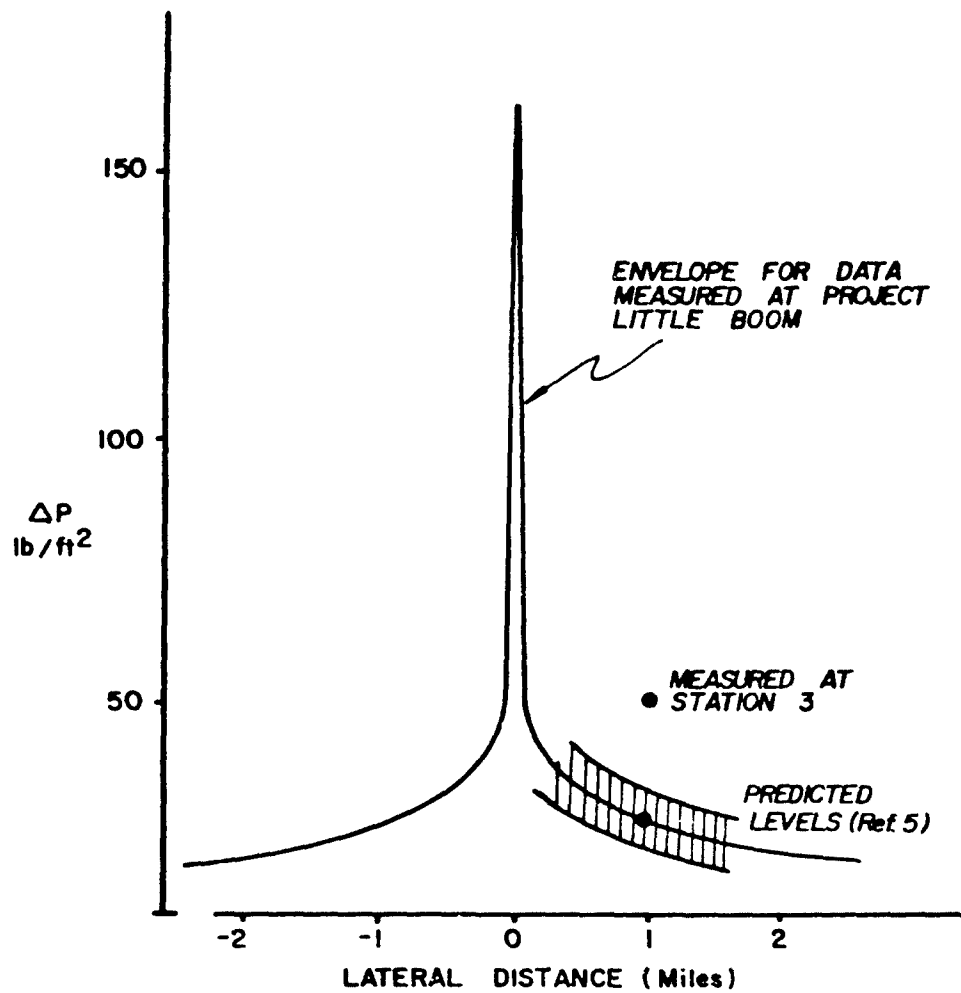
Fig. 11. Measurement at Station 3 of Single Sonic Boom Which Far Exceeds Predicted Levels Based on Measurements Obtained at Project Little Boom (Ref. 5)

At Station 3 located about 1 mile to the side of the center track (Stone Cabin Ranch) only one sonic boom was recorded. There were no obstructions between the ground track and the ranch buildings situated in a cul de sac naturally formed by small hills that opened toward the ground track. The peak overpressure of 50 psf measured at a distance of about 1 mile from the flight track was considerably higher than the 5-10 psf estimated for that particular flight. This estimate was made on the basis of similar data obtained from Project Little Boom and shown in figure 11. A satisfactory explanation for the high peak overpressure measured at Stone Cabin Ranch has not been obtained. Flight operations data indicate that no change in direction or no maneuver of the aircraft occurred during its closely monitored pass over Station 3 at the time of recording.

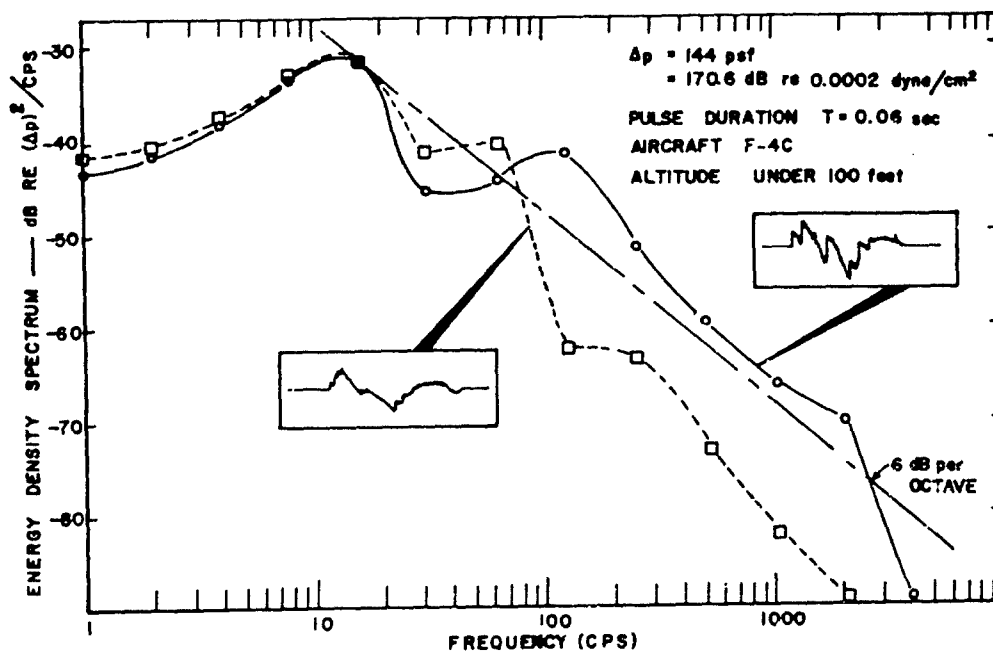
Fig. 12. Energy Density Spectrum of Two Measured Sonic Booms

Two recorded sonic booms were analyzed by Fourier methods (ref 7) utilizing an electronic computer and are shown in fig 12. The graph presents the energy density as a function of frequency. The energy density spectrum E for the signal is

Where T = duration of the boom pressure pulse, $p(t)$ = pressure time function and $\omega = 2\pi f$, where f = frequency. Both signatures were generated by the same type aircraft, at about the same altitude and have the same peak overpressure of about 144 psf. One was recorded by the reference Photocon system and does not appear in the summary table.

The energy density spectrum of the signature with larger numbers of individual components contained more energy in the high frequency bands (solid lines) even though the fundamental frequencies were identical. Sonic booms with multi-saw tooth components and faster rise time, e.g., more energy in the high frequency bands, are judged to be louder than those without these components but of the same peak overpressure (ref 8).

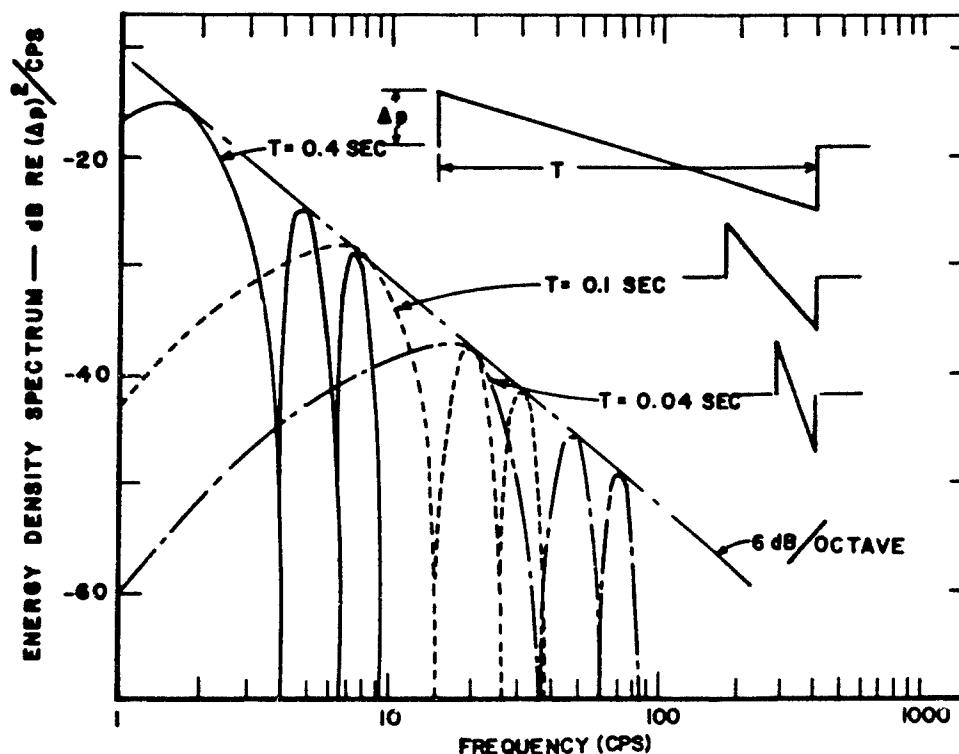
Fig. 13. Calculated Energy Density Spectrum of Idealized Sonic Booms of Different Duration

Energy density spectrum analyses of various idealized sonic booms ($\Delta T = 0.04, 0.40$, and 4.00 seconds) were calculated and are shown in figure 13. A sonic boom with a duration of $\Delta T = 0.04$ seconds is typical of a fighter aircraft at low altitude and $\Delta T = 4.0$ sec is representative of an SST size aircraft. For $\Delta T = 0.04$ seconds, the fundamental frequency peaks at 17 cps, for $\Delta T = 0.4$ it is 1.7 cps and is 10 dB lower in magnitude than the longer boom.

The energy density spectra of the measured sonic booms agree closely with those of the idealized booms. The measured sonic booms have a $\Delta T = 0.08$ seconds, which corresponds to a fundamental of 17 cps and are 22 dB below ΔP . In general, a roll-off of 6 dB per octave from the fundamental is the same for both the measured and the idealized sonic booms.
